# "AQUAPATCH"

Applied Examples @横浜市磯子区杉田4-5-28 クリア5mm

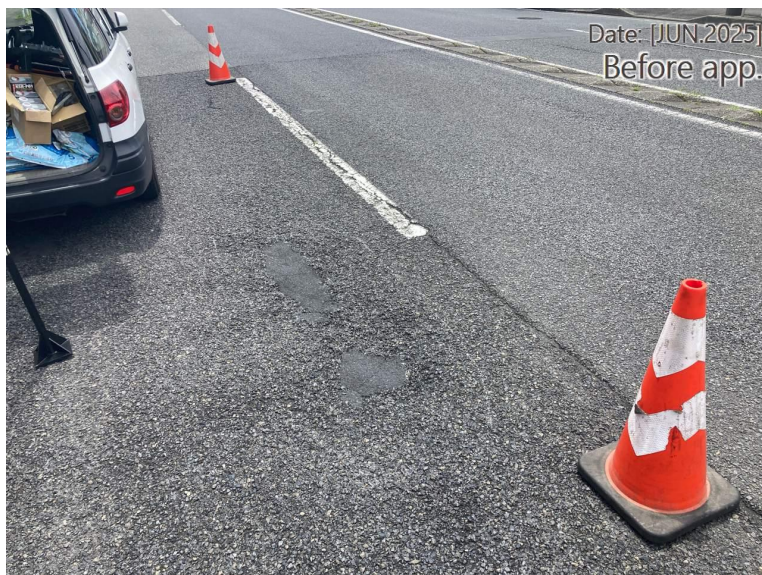
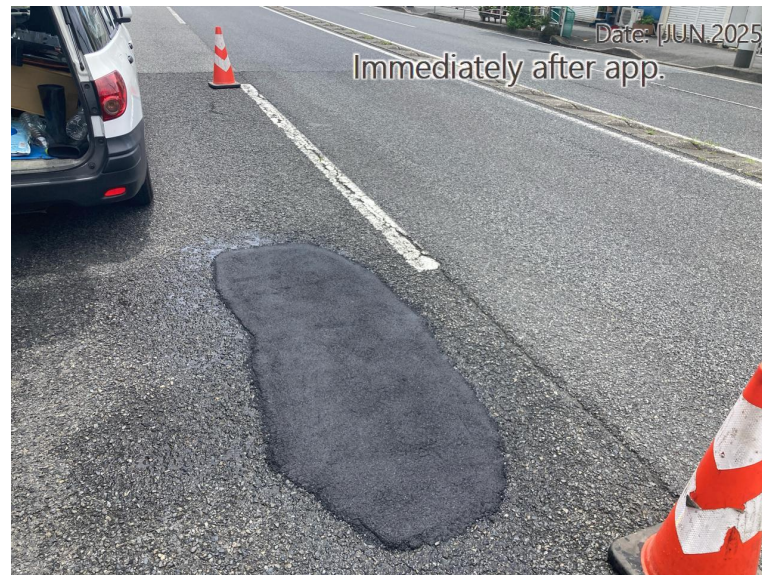
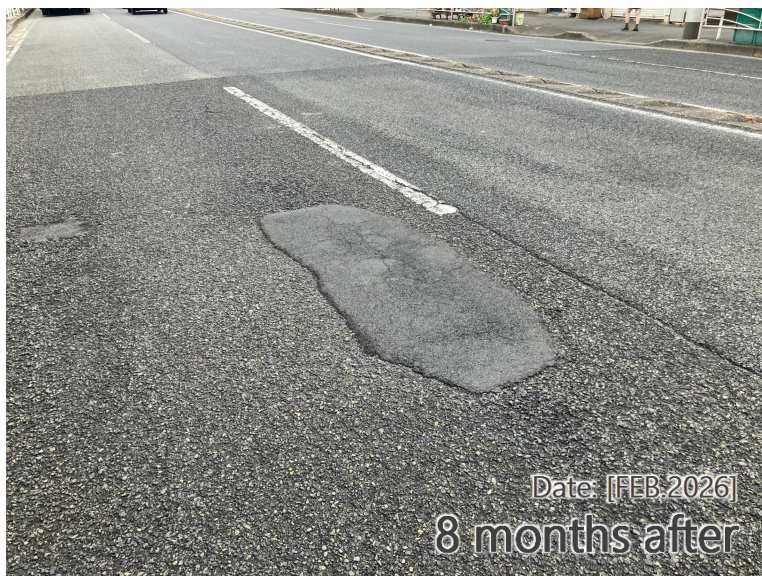
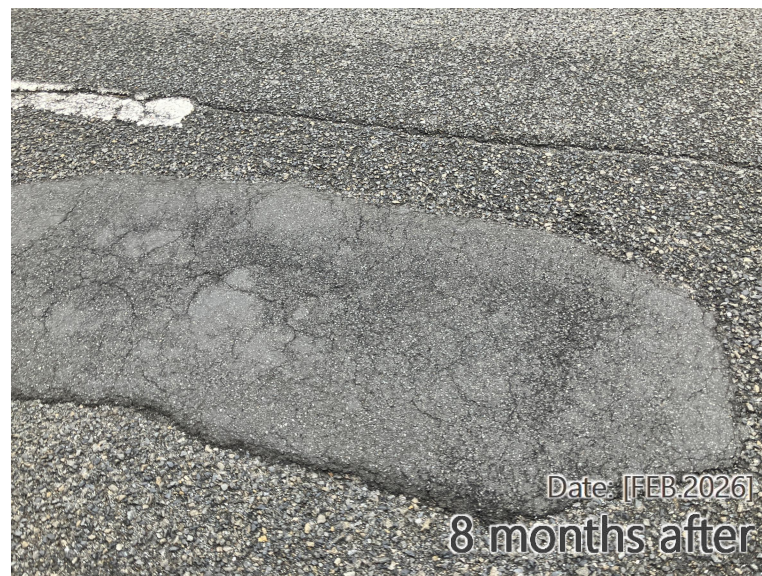
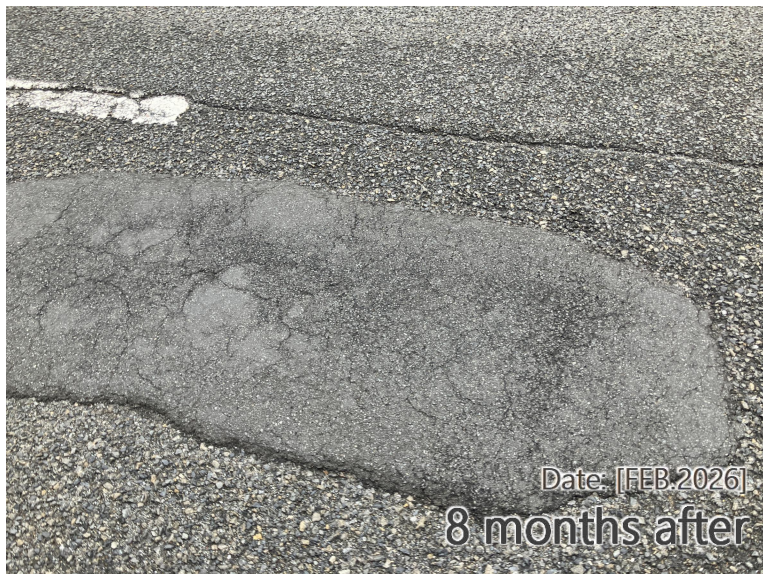
National Route 16 — This is a road with very heavy traffic, where both passenger vehicles and large trucks frequently pass. Although some cracking has occurred, the repair has remained effective for eight months after application, successfully filling the pothole.

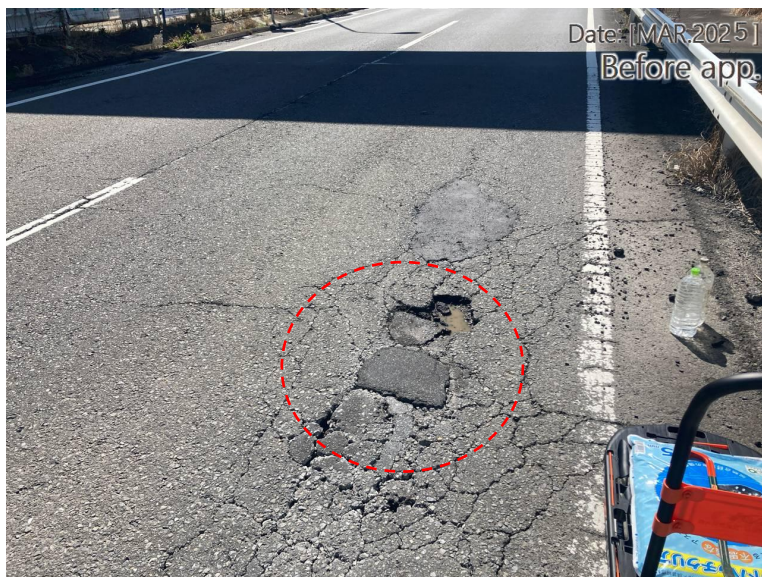
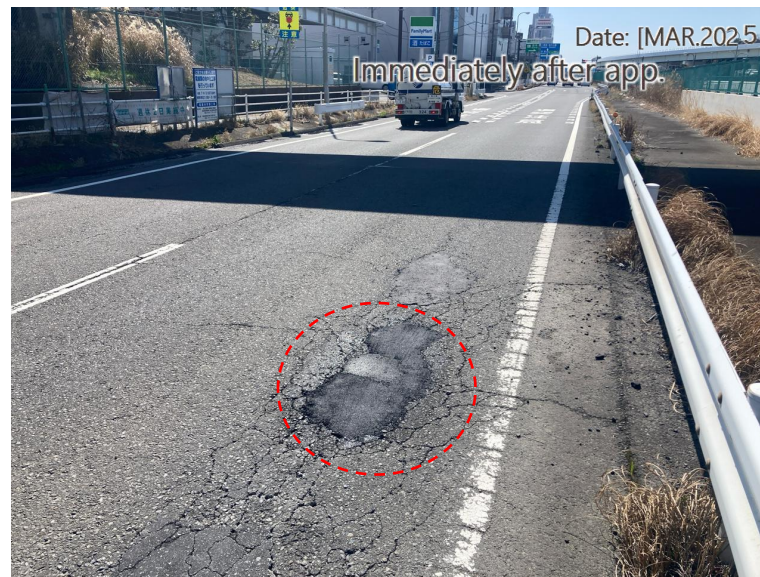
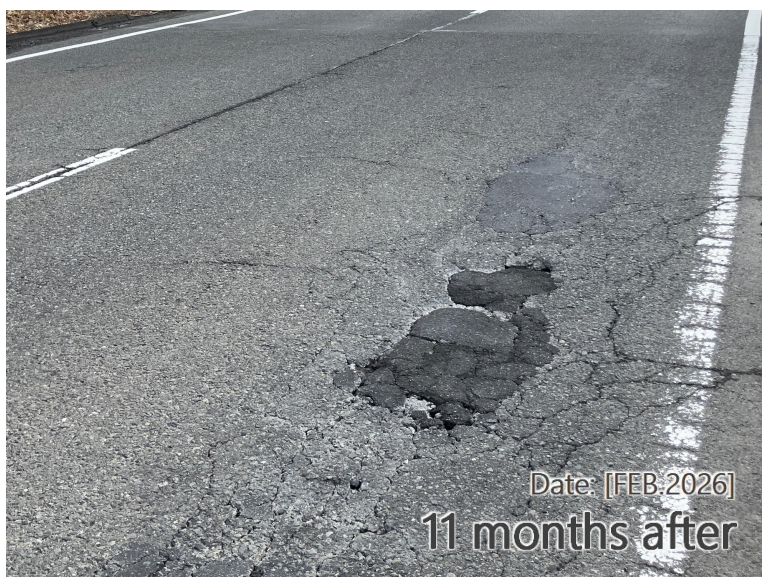
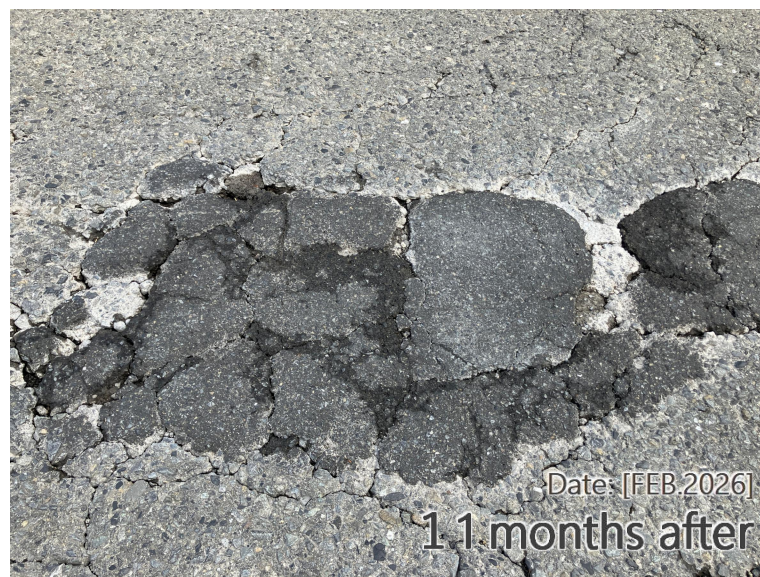
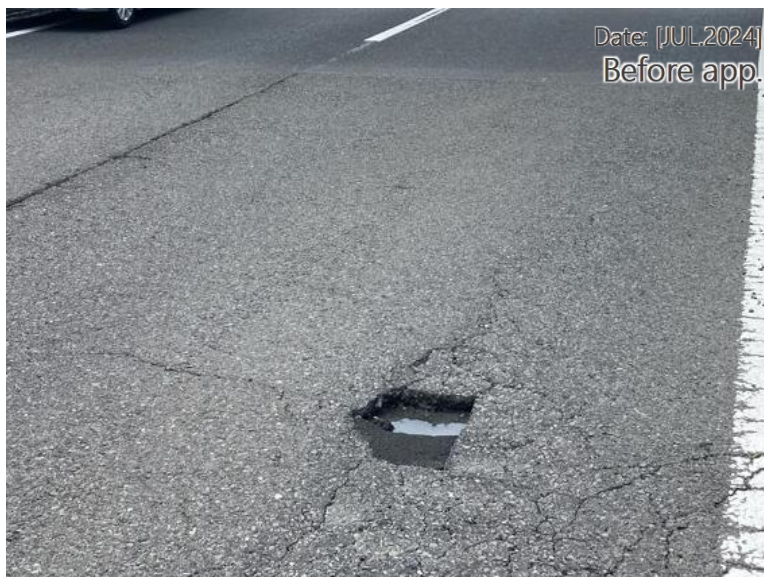
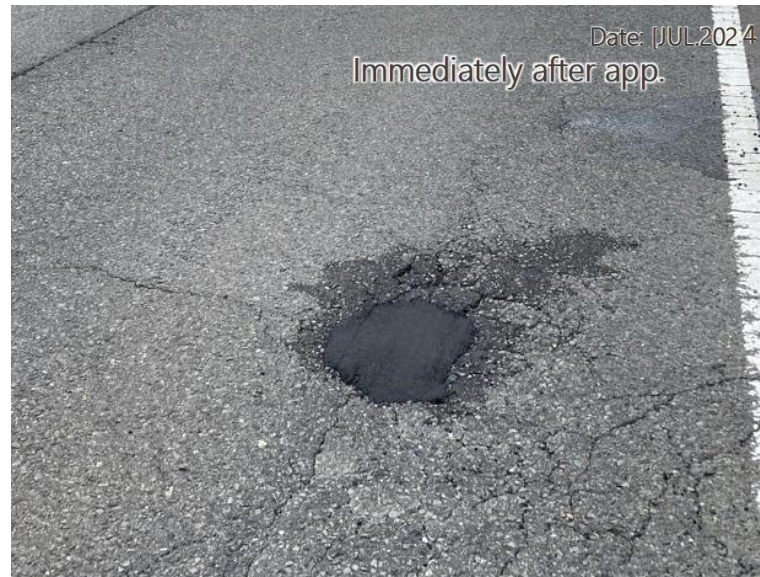
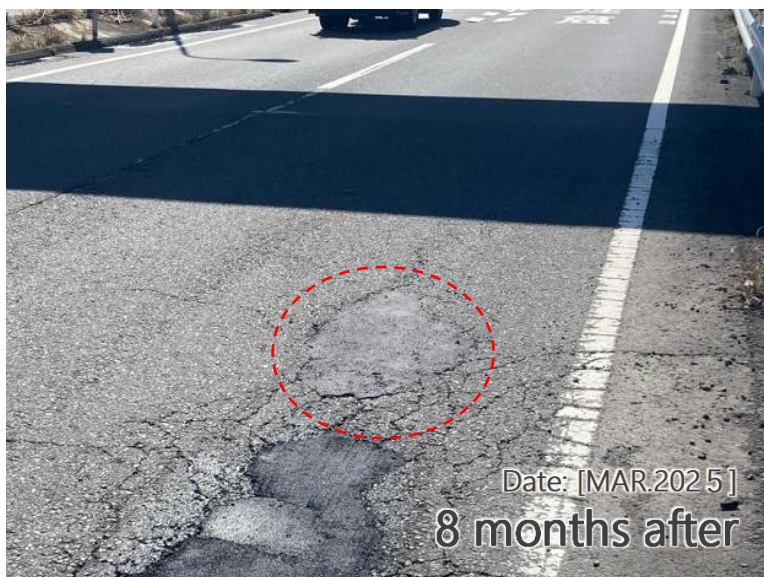
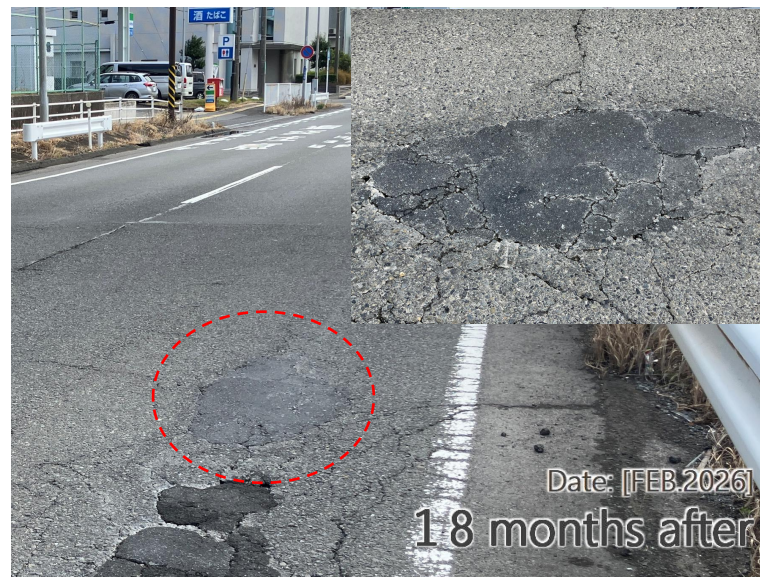
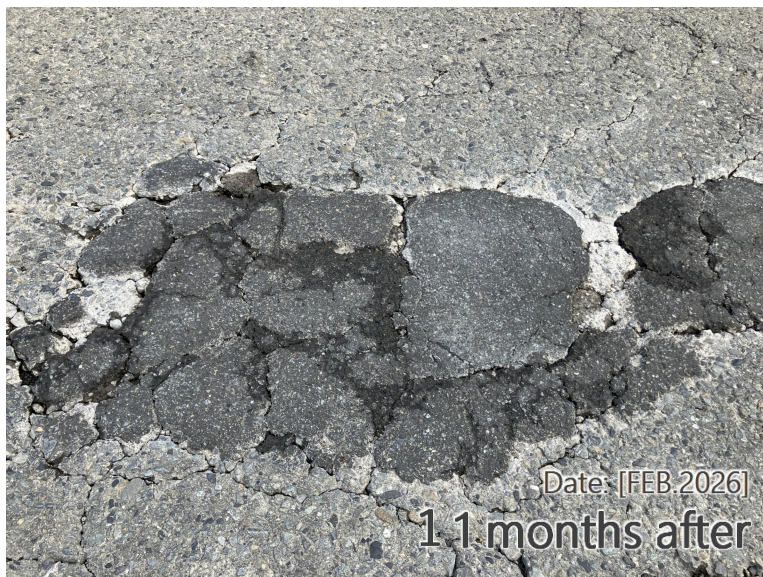
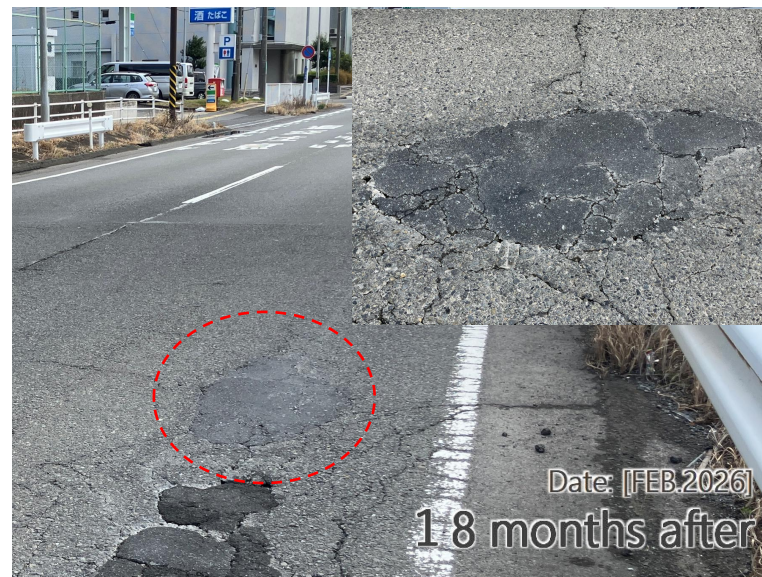
Applied Examples @横浜市金沢区幸浦2-1-20 クリア5mm

National Route 357 — This is a heavily trafficked road serving as a bypass connecting to the port, with a high volume of logistics-related heavy vehicles.

The damage originates from the base layer, and while surface-level repair alone is technically insufficient, full-depth rehabilitation would be large-scale and time-consuming. Therefore, a temporary but durable repair is required to extend the service life until proper reconstruction can be carried out.

When repaired with conventional cold mix asphalt, potholes require refilling frequently (approximately once every two days), which is not practical. Although some cracking occurs, the durability of AQUA PATCH allows it to remain in the pothole without peeling off, maintaining the repair in place.

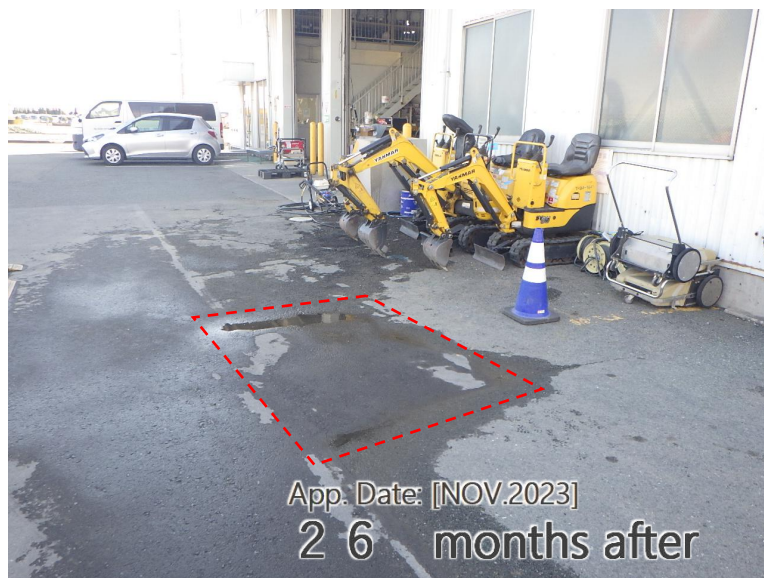
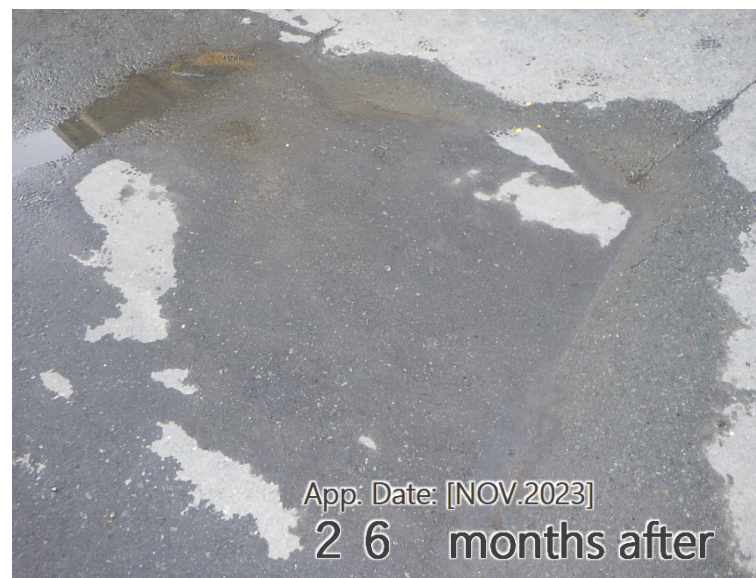
Applied Examples @静岡県榛原郡吉田町神戸1036-1 5mm

This is a parking area within a facility where heavy machinery occasionally passes, but overall traffic volume is not high. More than two years after application, no cracking has occurred and no visible pavement distress has been observed.
